MULTIAQUA s.r.o. VEŠPERKOVA 1343 500 02 HRADCE KRÁLOVÉ IČ: 626013111 TEL: +420 485 DIČ: CZ626013111 WWW.MULTIAQUA.CZ
Ing. Pavel Romáňšek	Ing. Pavel Romáňšek	Ing. Lubor Dítě	
Kraj: Středočeský	Obec: Náchod		
Investor: Povodí Labe, státní podnik, Vála Nejedlého 951, 500 03 Hradce Králové			
Metuje, Náchod, odstranění nánosů, ř. km 35,920 – 36,470			
Příčné řezy			
Stupeň Datum Zakázkové číslo Formát Měřítko: 1: 100/100			
ohlášení leden 2017 M17/03 10 x A1 Číslo přílohy			
Předložená dokumentace je duševním vlastnictvím firmy Multiaqua s.r.o., Hradec

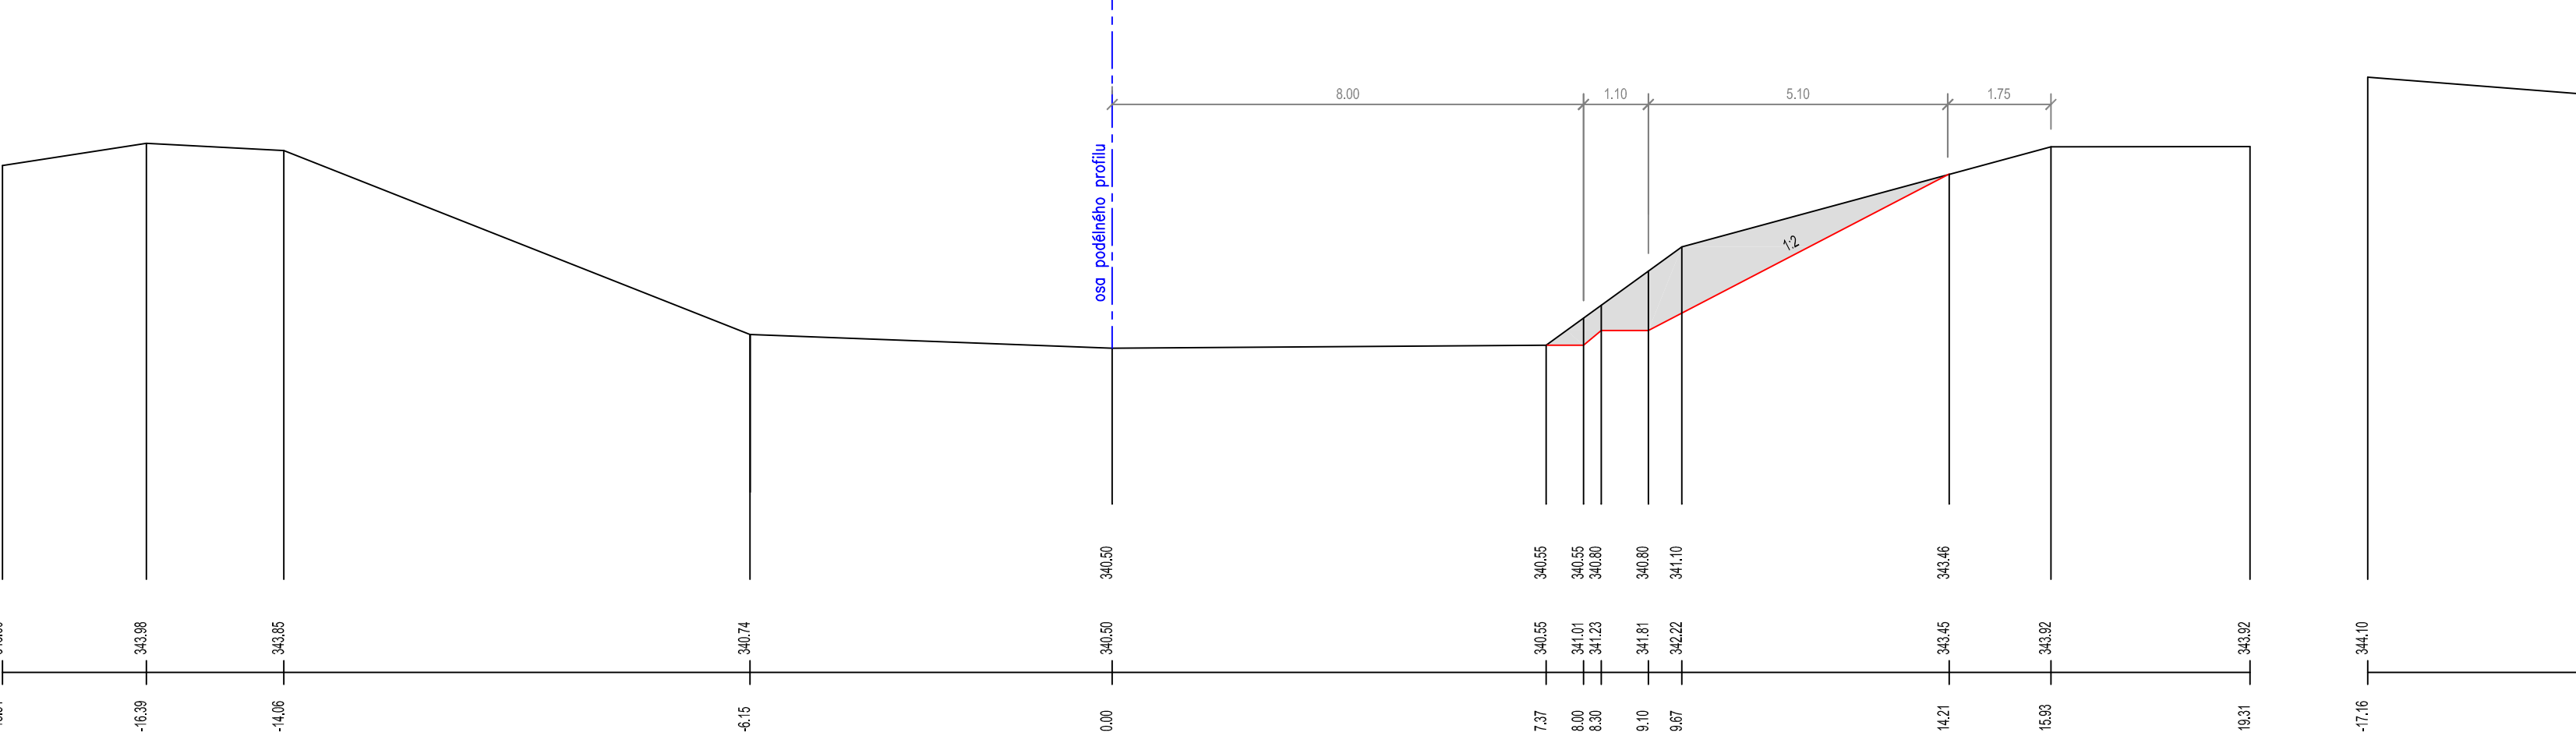
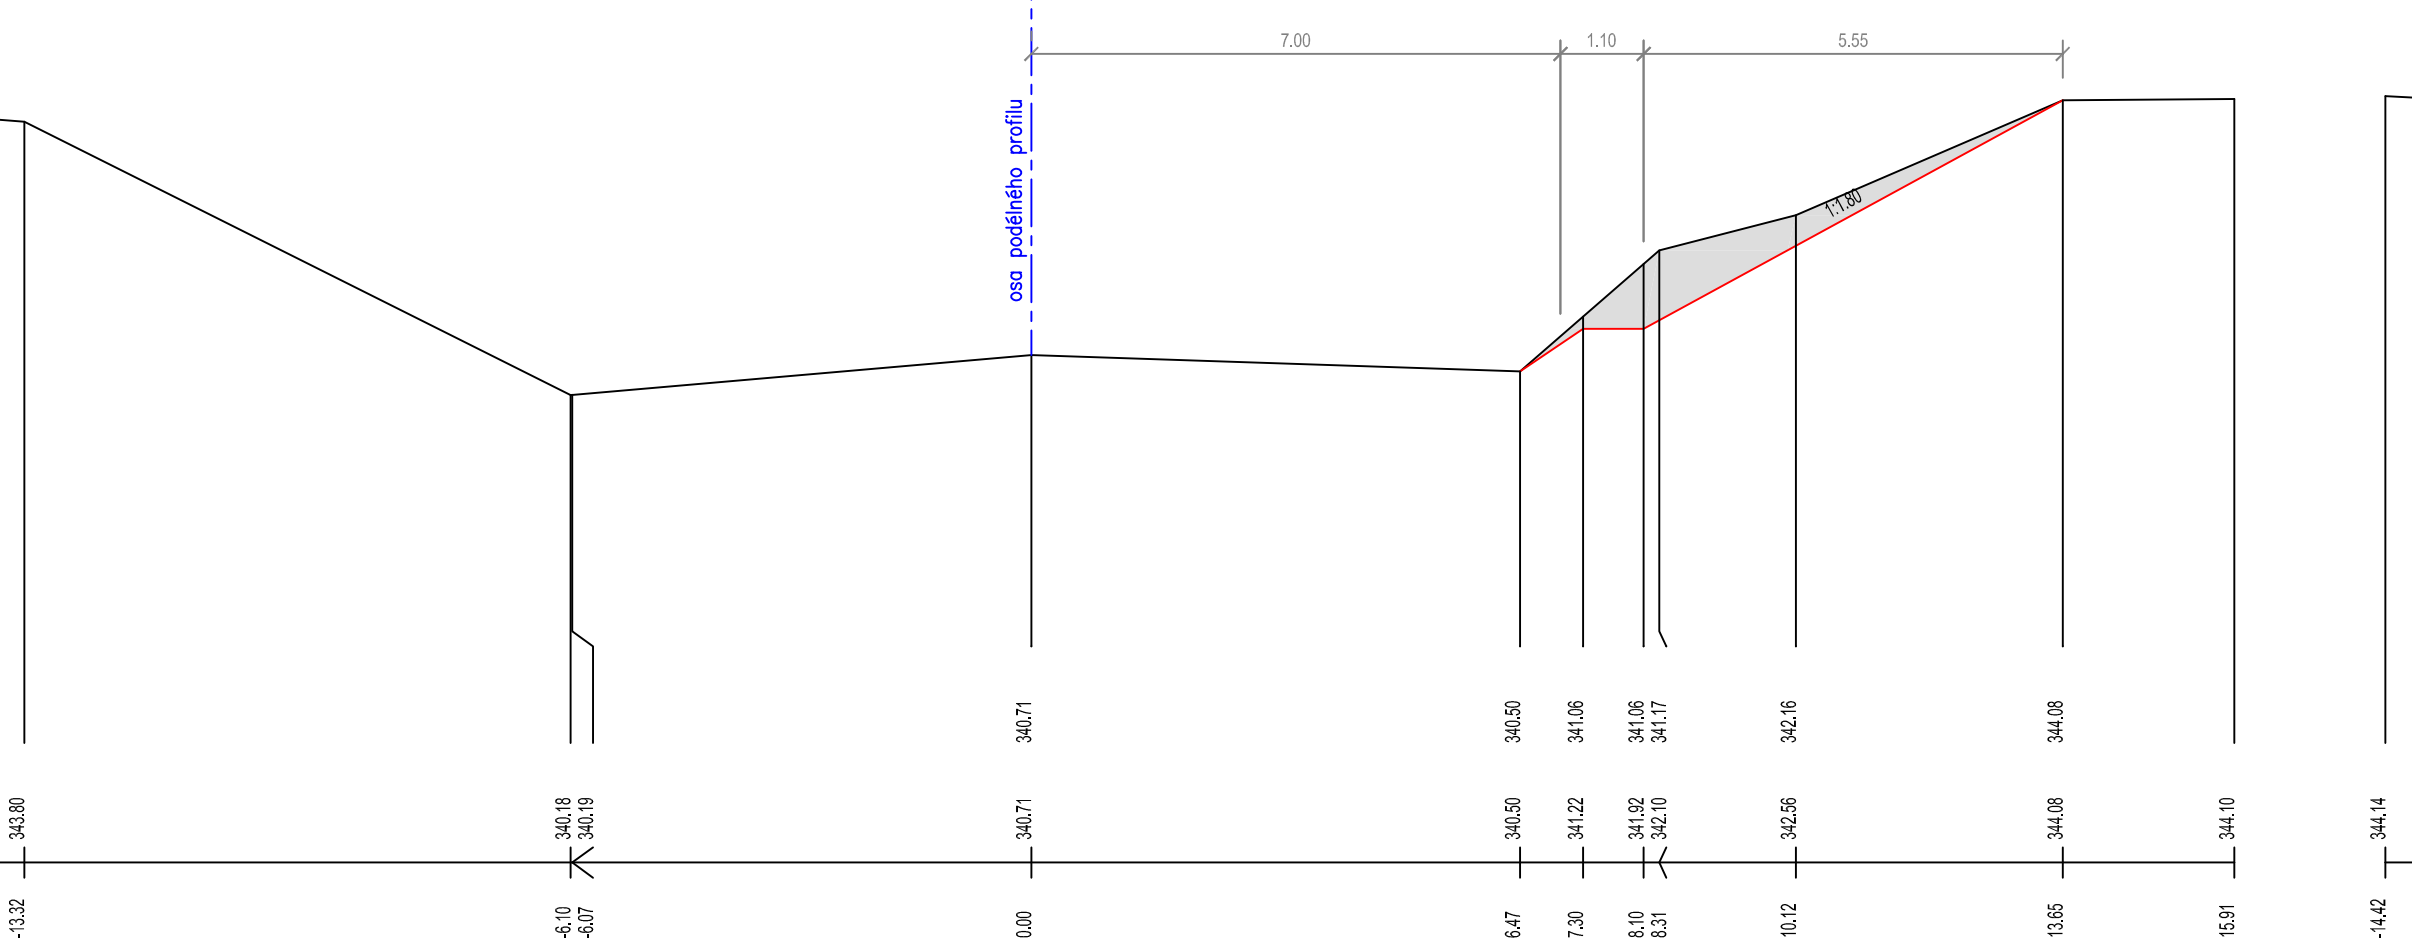
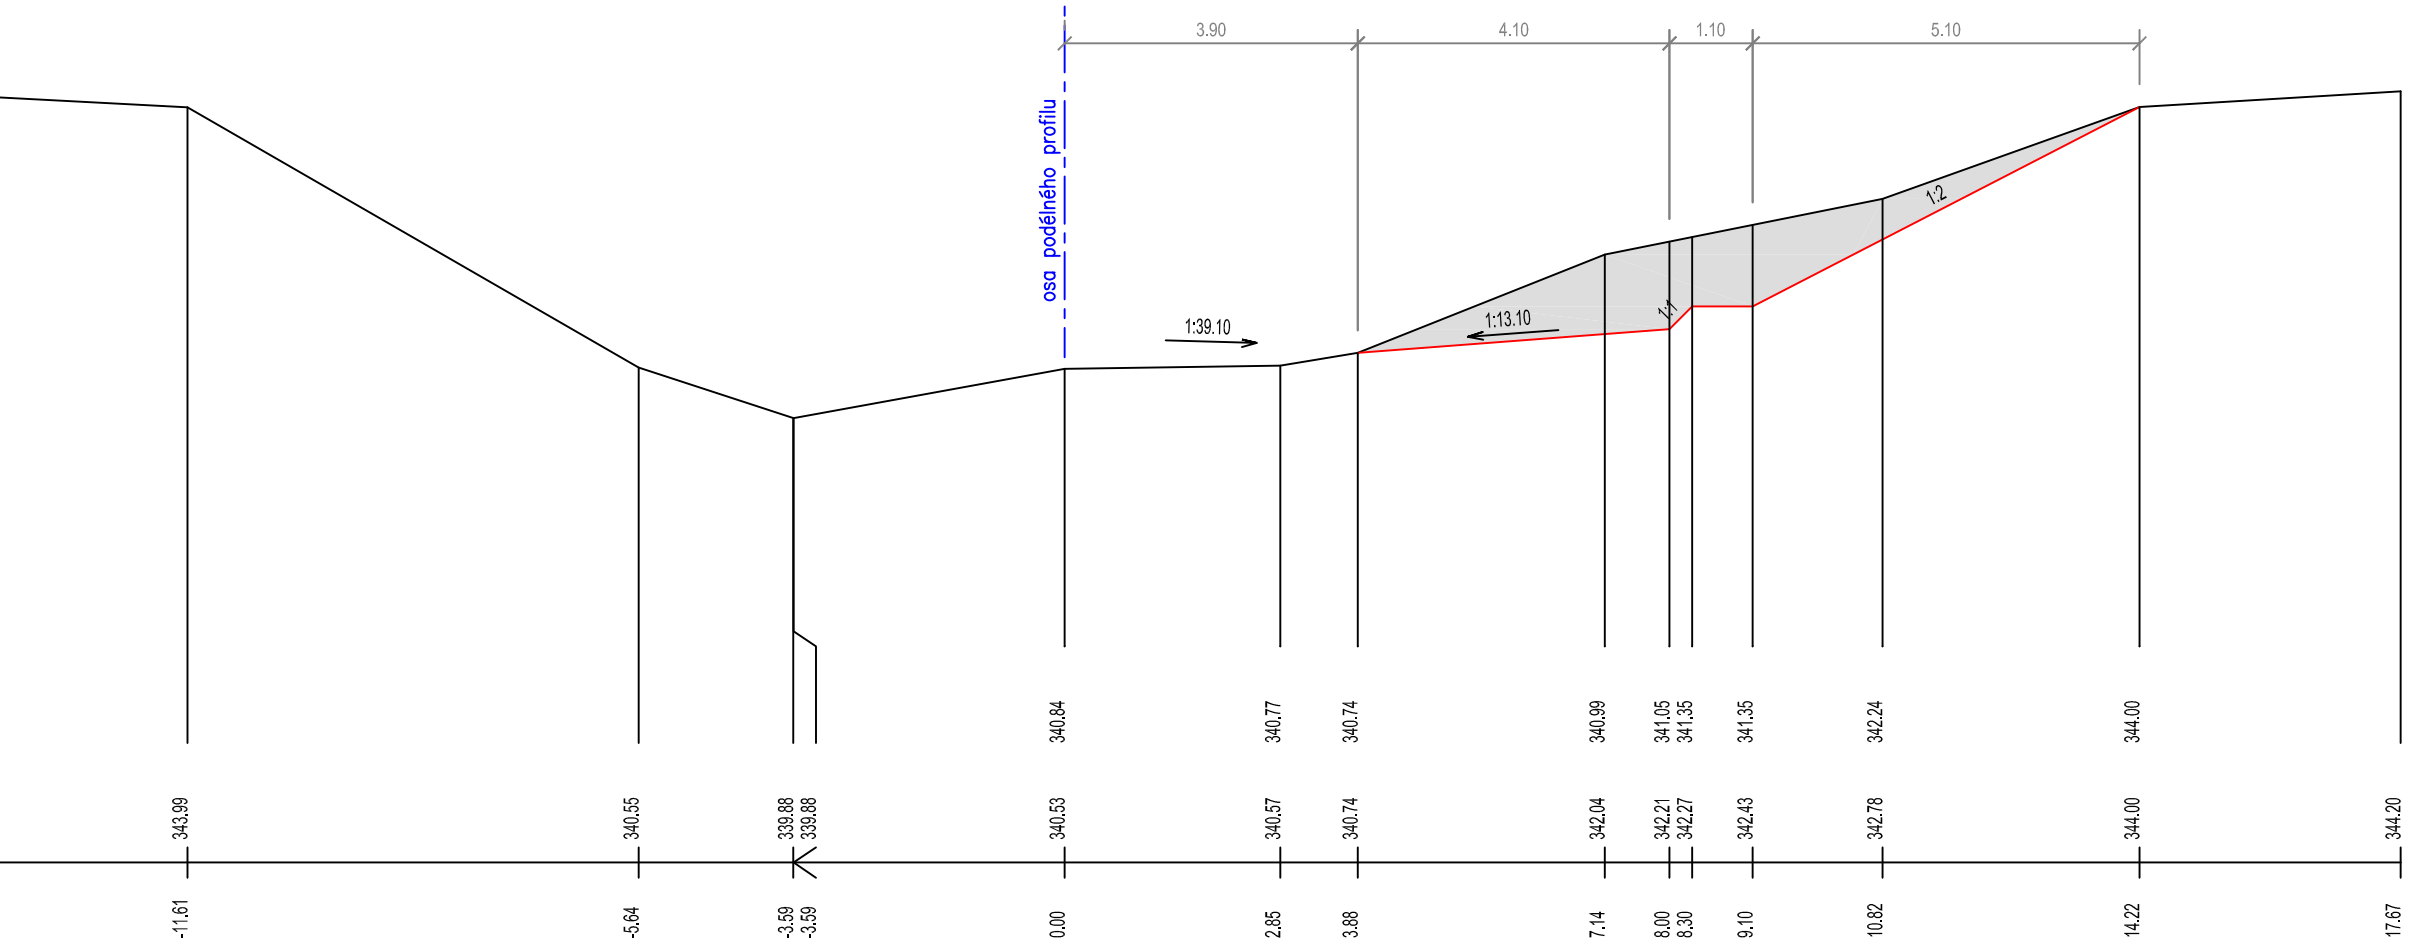
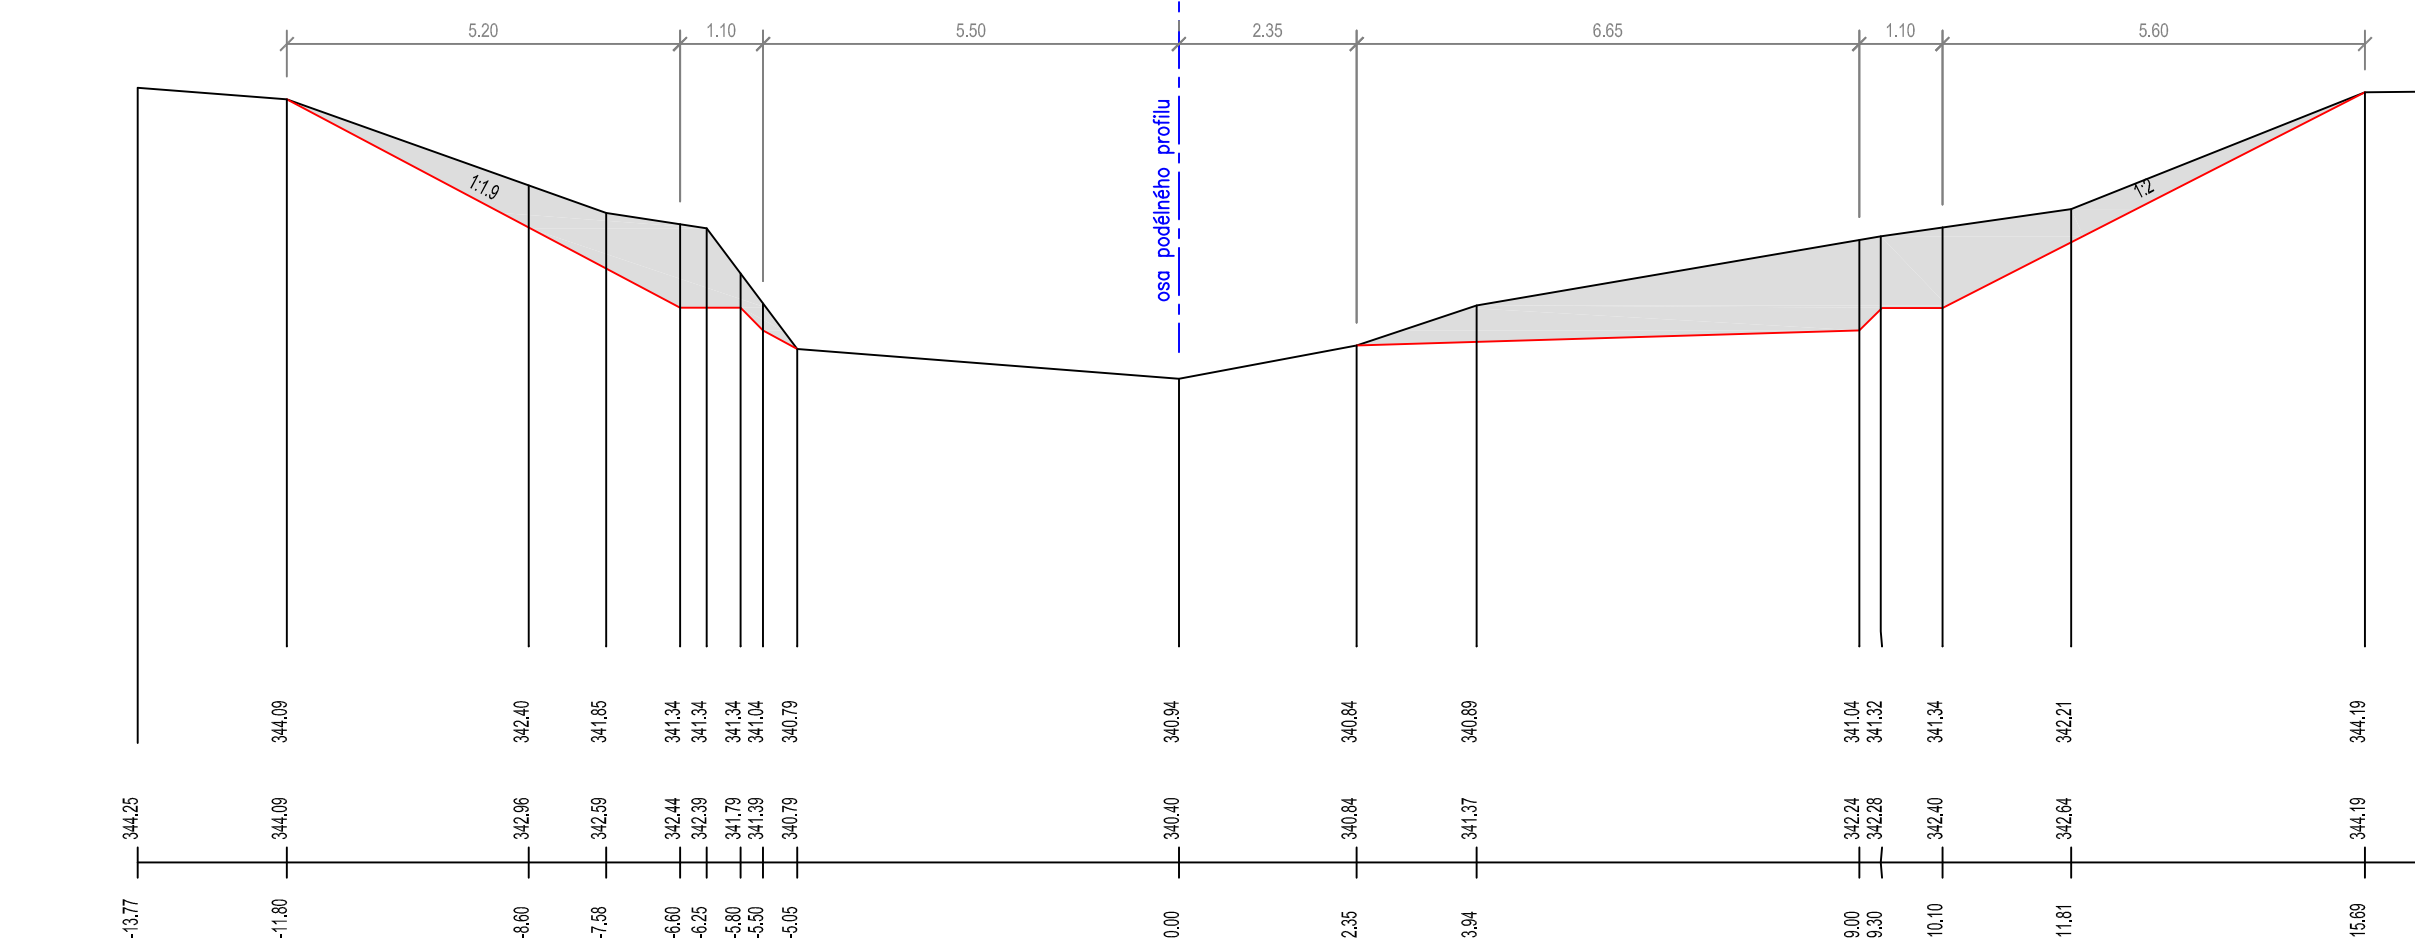
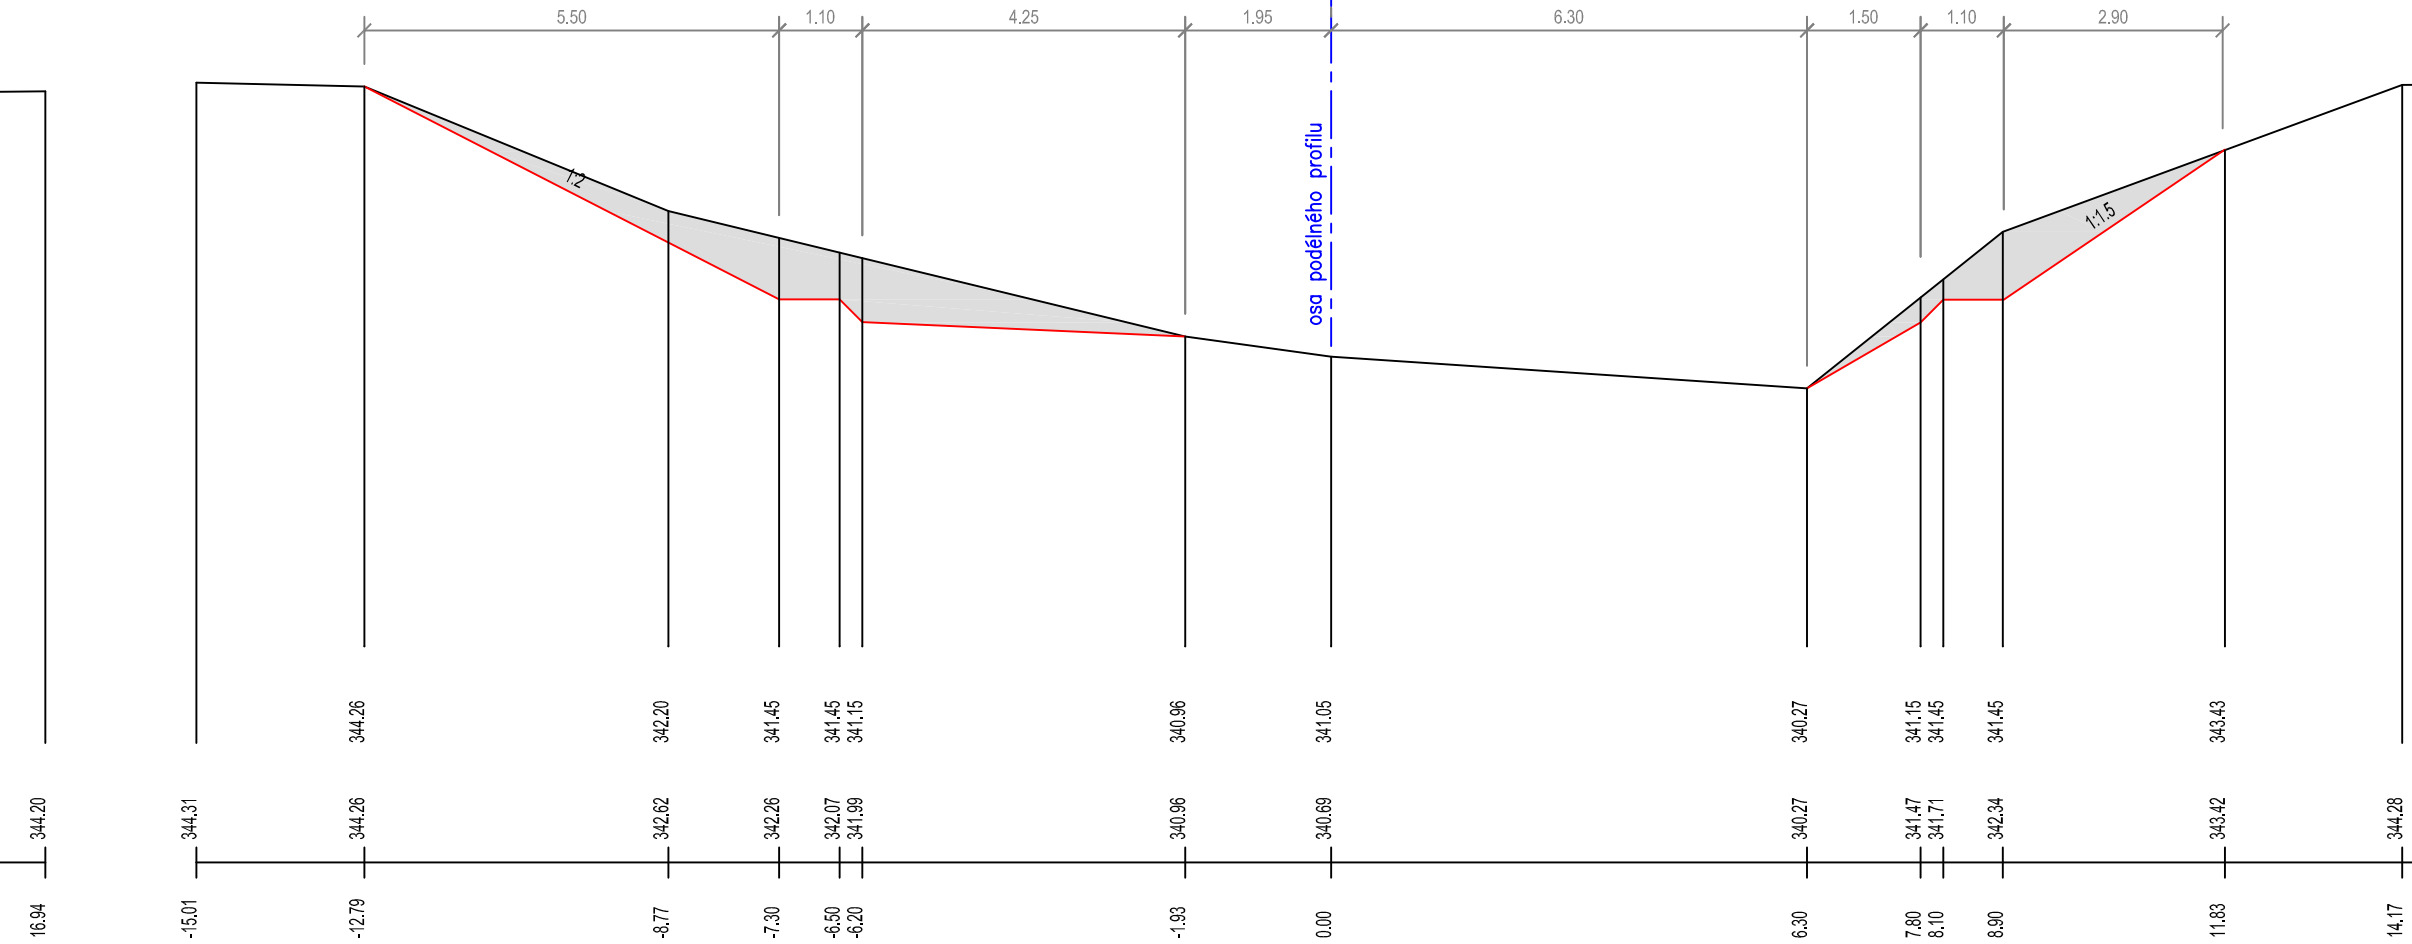
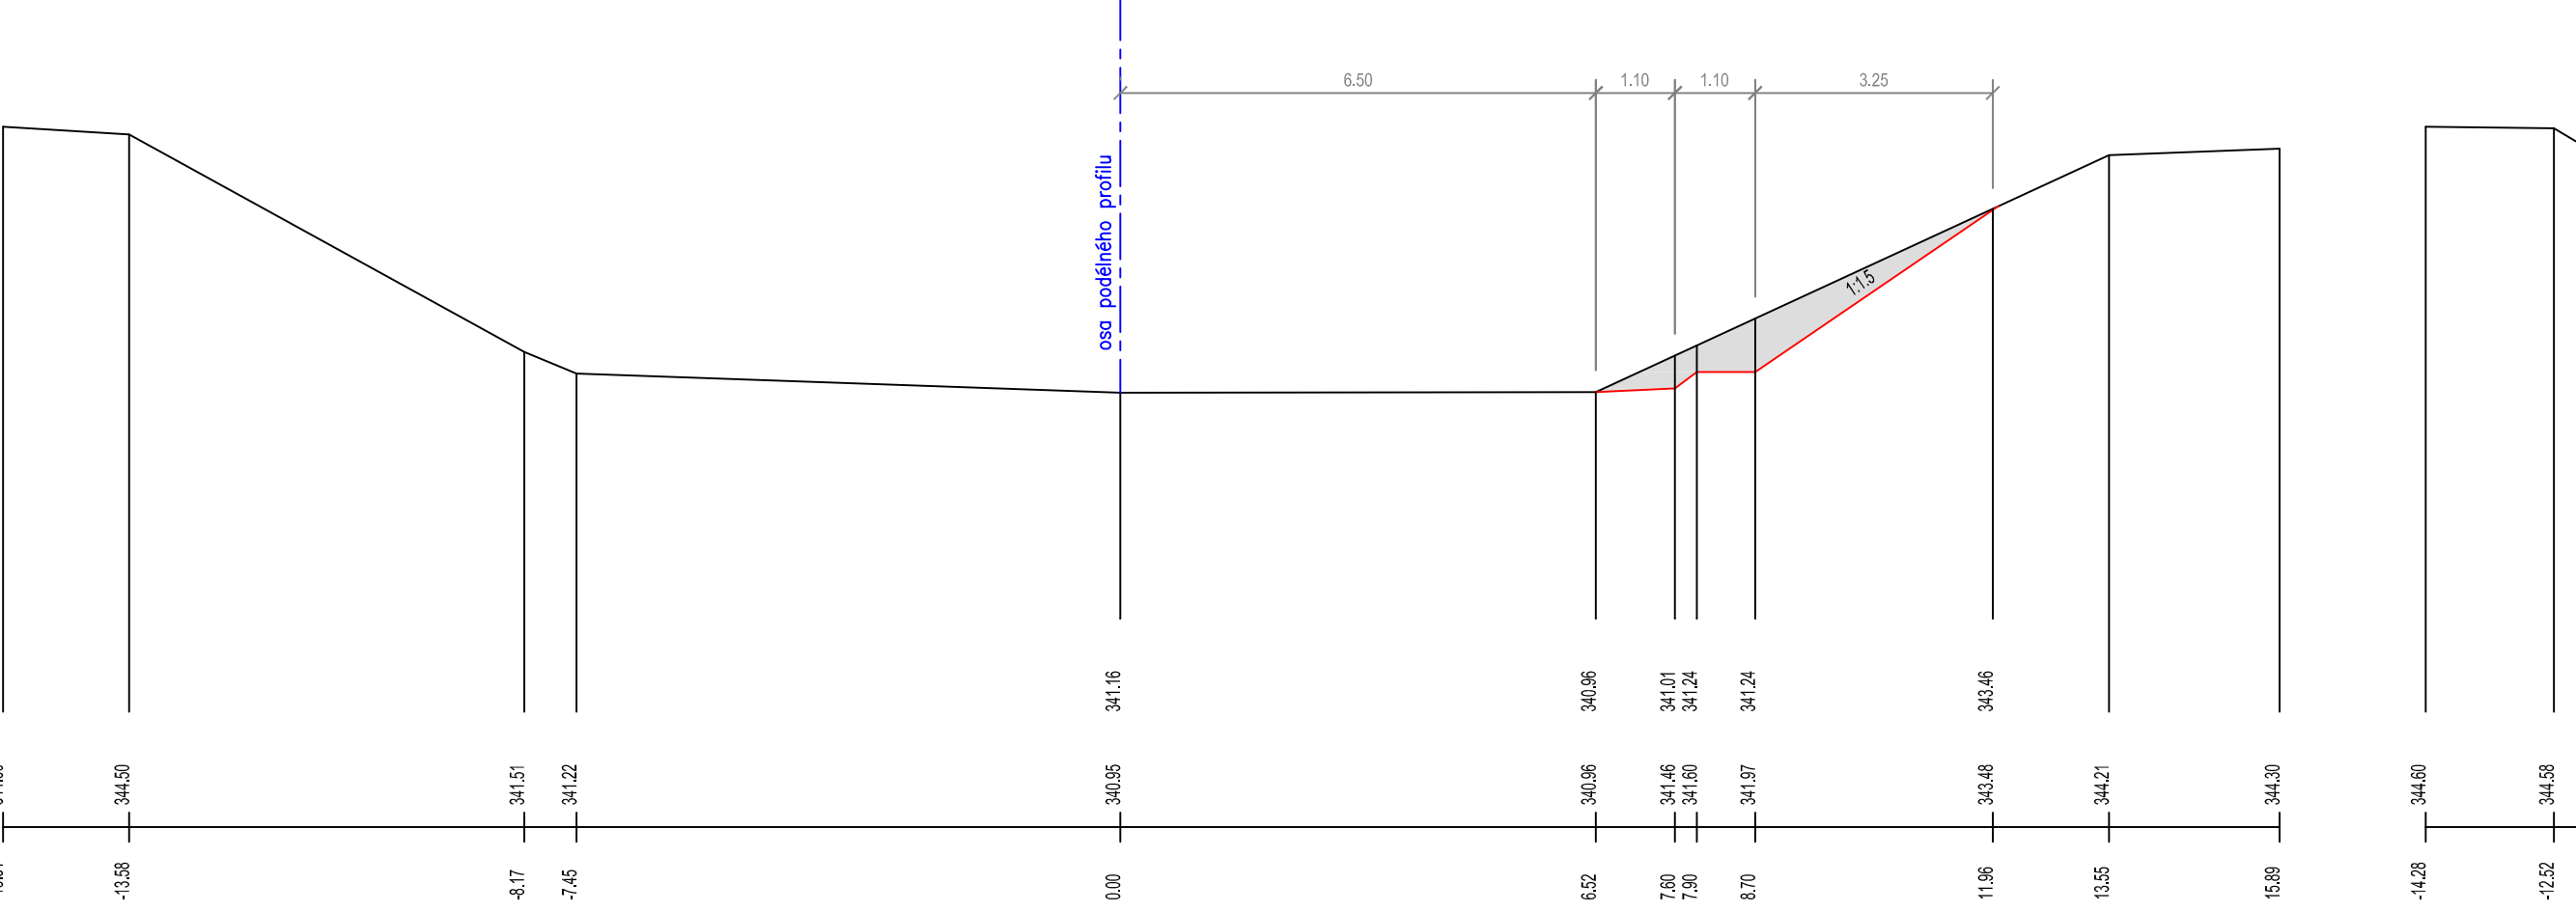
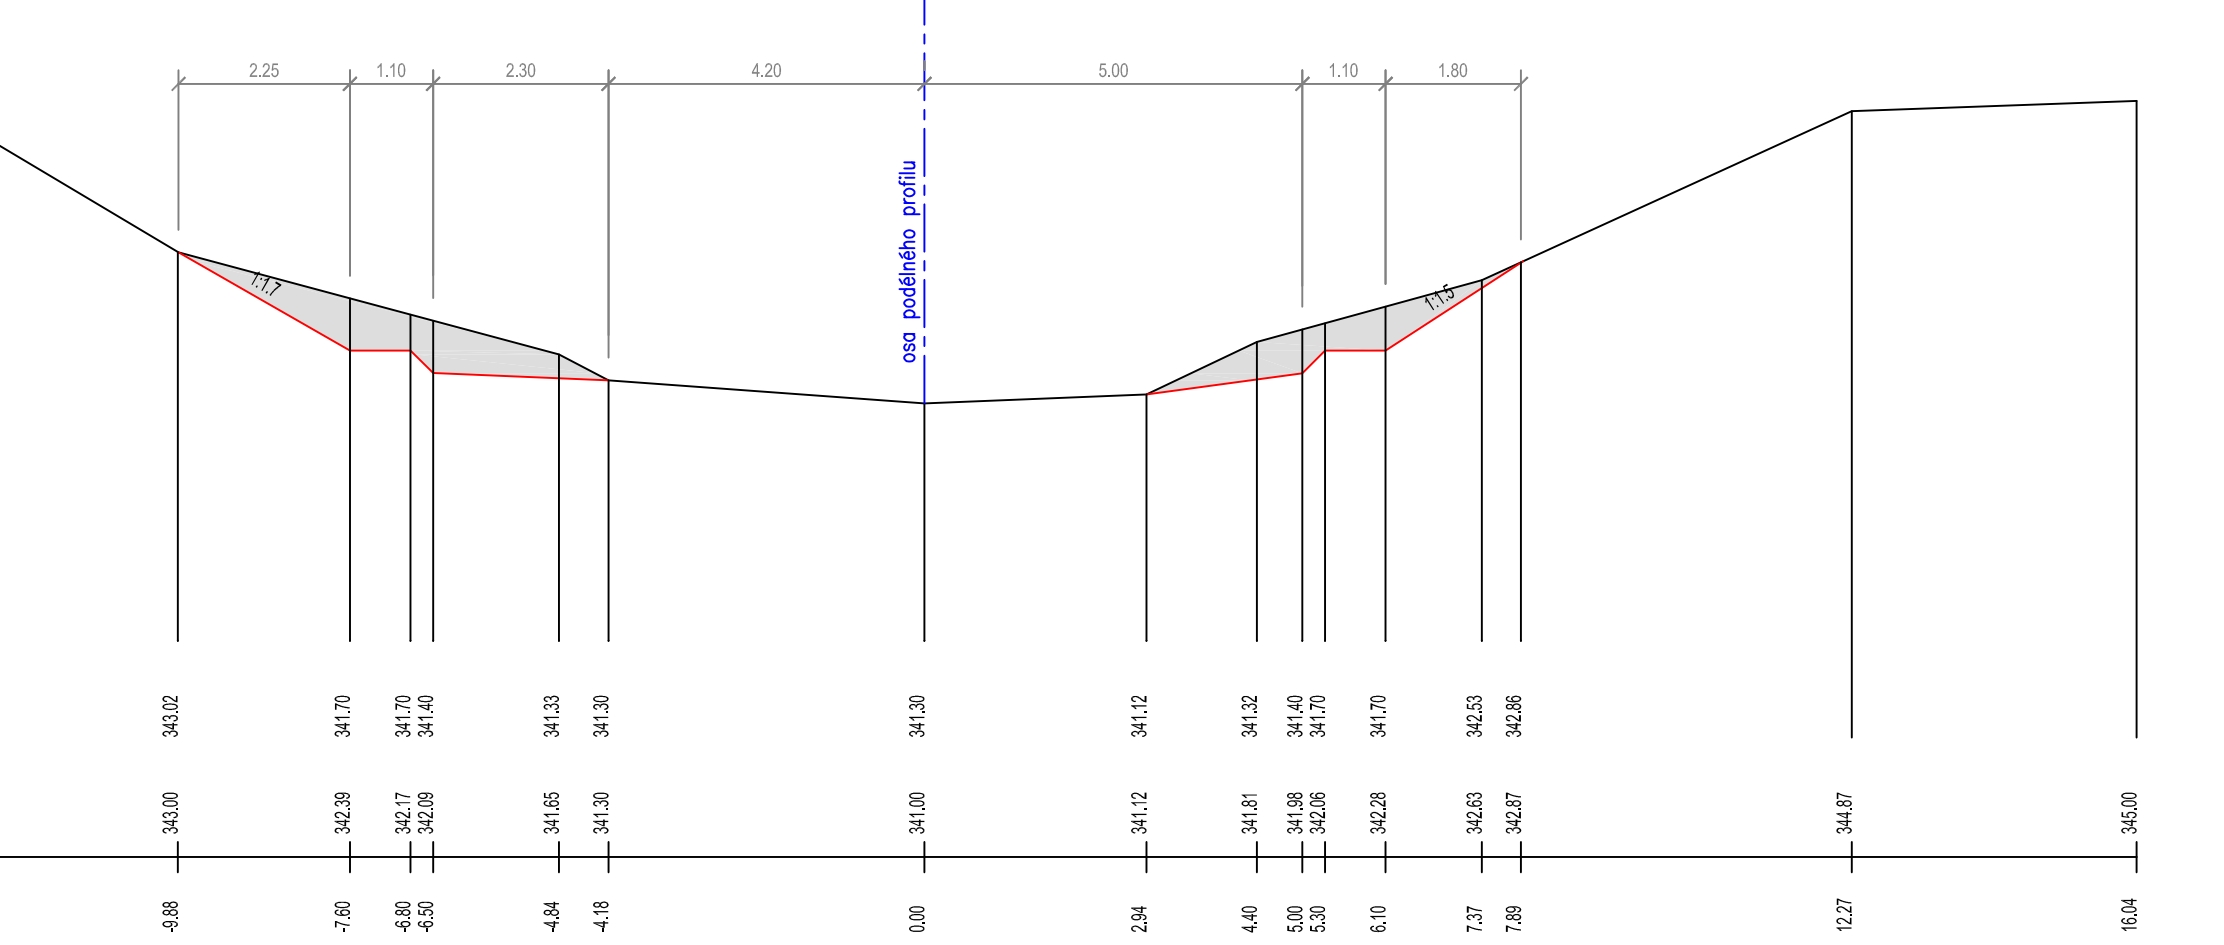
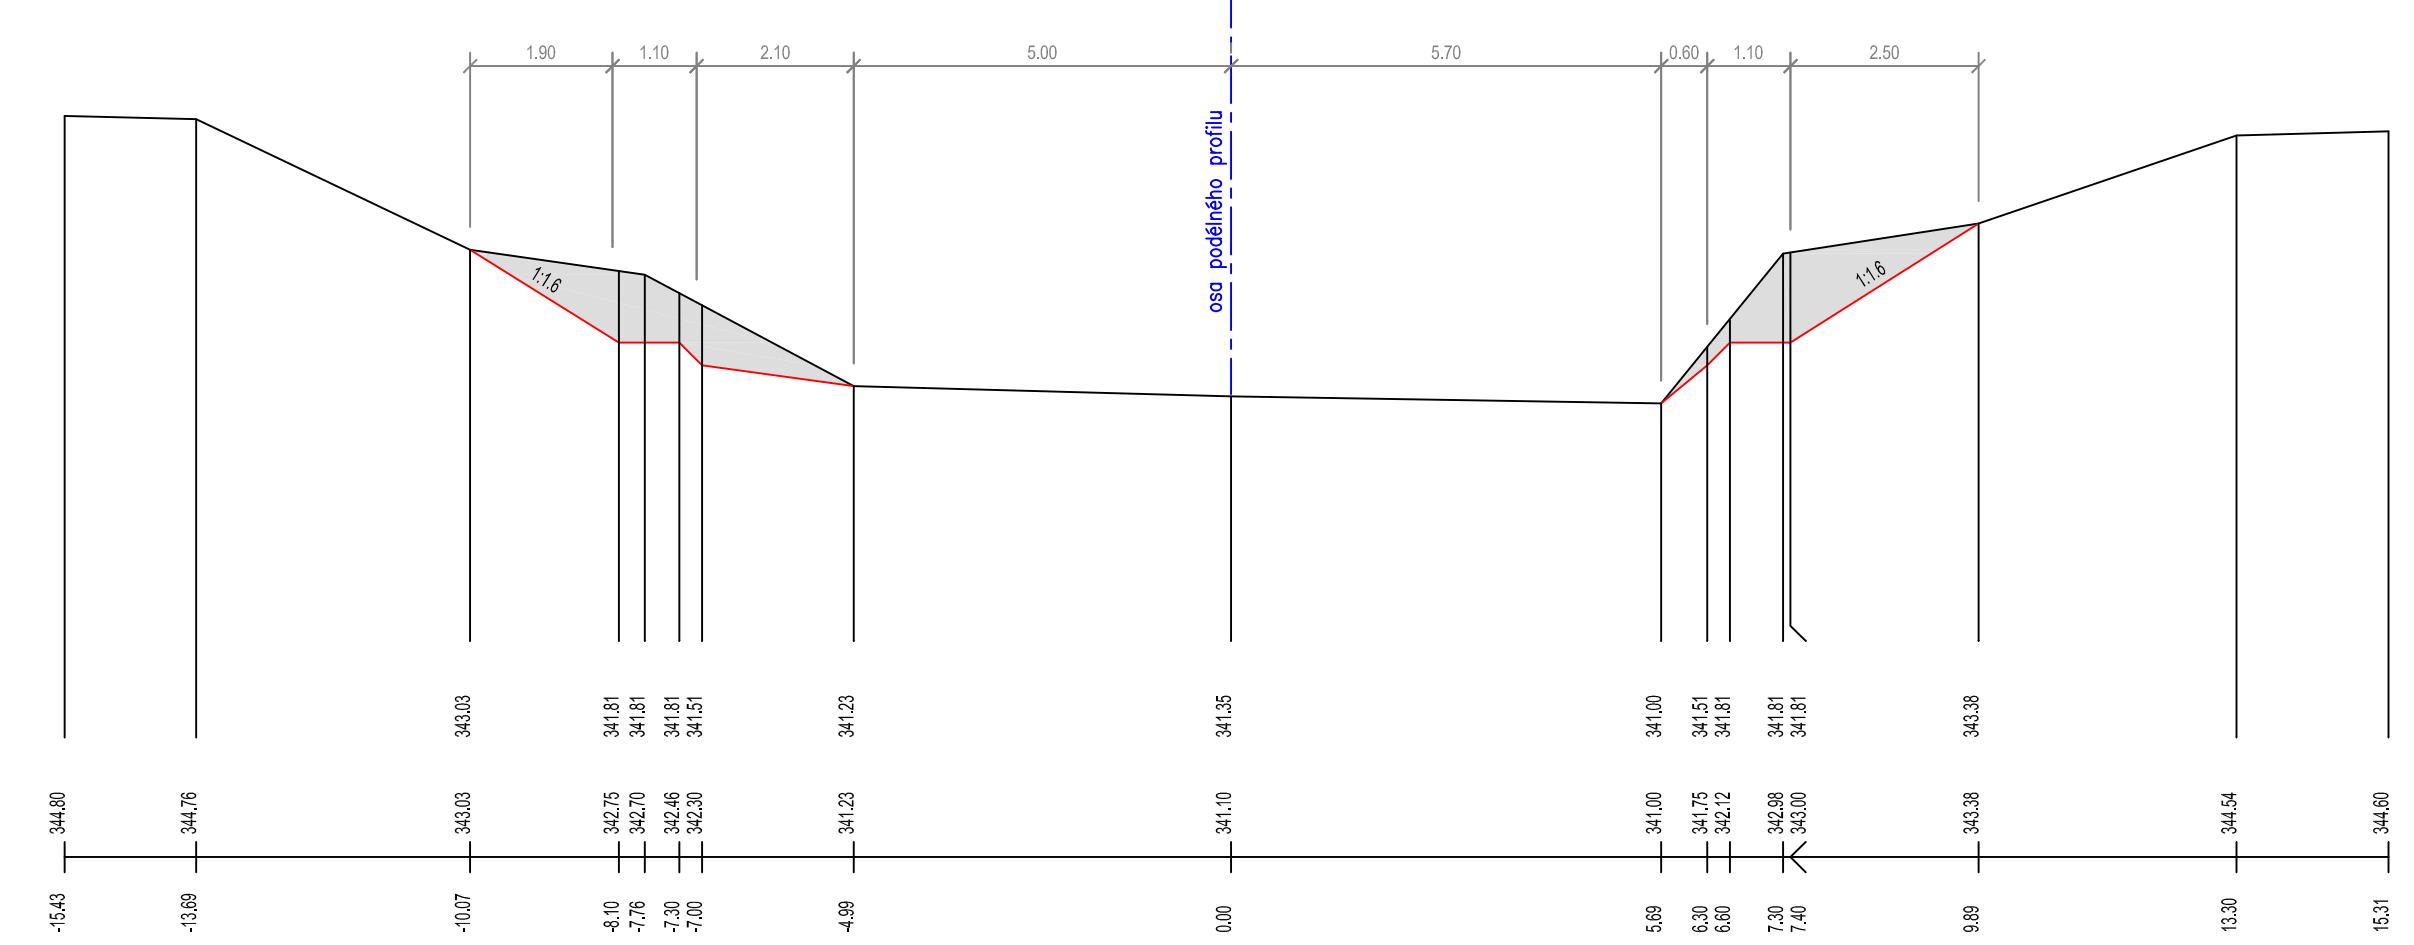
staničení [km]	řez	výkop	
		[m2]	[m3]
35.92	P01	4.25	0.0
35.99	P02	3.61	224.6
36.05	P03	7.62	284.5
36.10	P04	13.34	431.6
36.16	P05	11.24	522.7
36.22	P06	2.60	241.5
36.25 (lavice pod mostem)		115.00	57.5
36.29	P07	10.37	208.9
36.34	P08	7.38	212.0
36.39	P09	4.89	269.7
36.46	P10	3.62	254.1
CELKEM:			2707.0
