<b>AQUA CENTRUM</b> Břeclav s.r.o.
Ing. Milan Bartolšic	Ing. Jan Vараdinek		
Investor: Povodí Moravy, s.p., Dřevařská 11, 60200 Brno			Kapusta 27, 690 06 Břeclav IČO 60710063, DIČ CZ60710063 tel.: 519 333 689, email: aqc@wo.cz
Nace: <b>Jez Olomouc - oprava strojoven (fasáda a zastřešení)</b>			Formát  Datum červen 2020  Číslo stavby
Příloha: VÝKRES POV POMOCNÁ NOSNÁ KONSTRUKCE LEŠENÍ PŮDORYS, ŘEZY			Měřítko 1:50  Číslo přílohy <b>D.1.1.b.8</b>

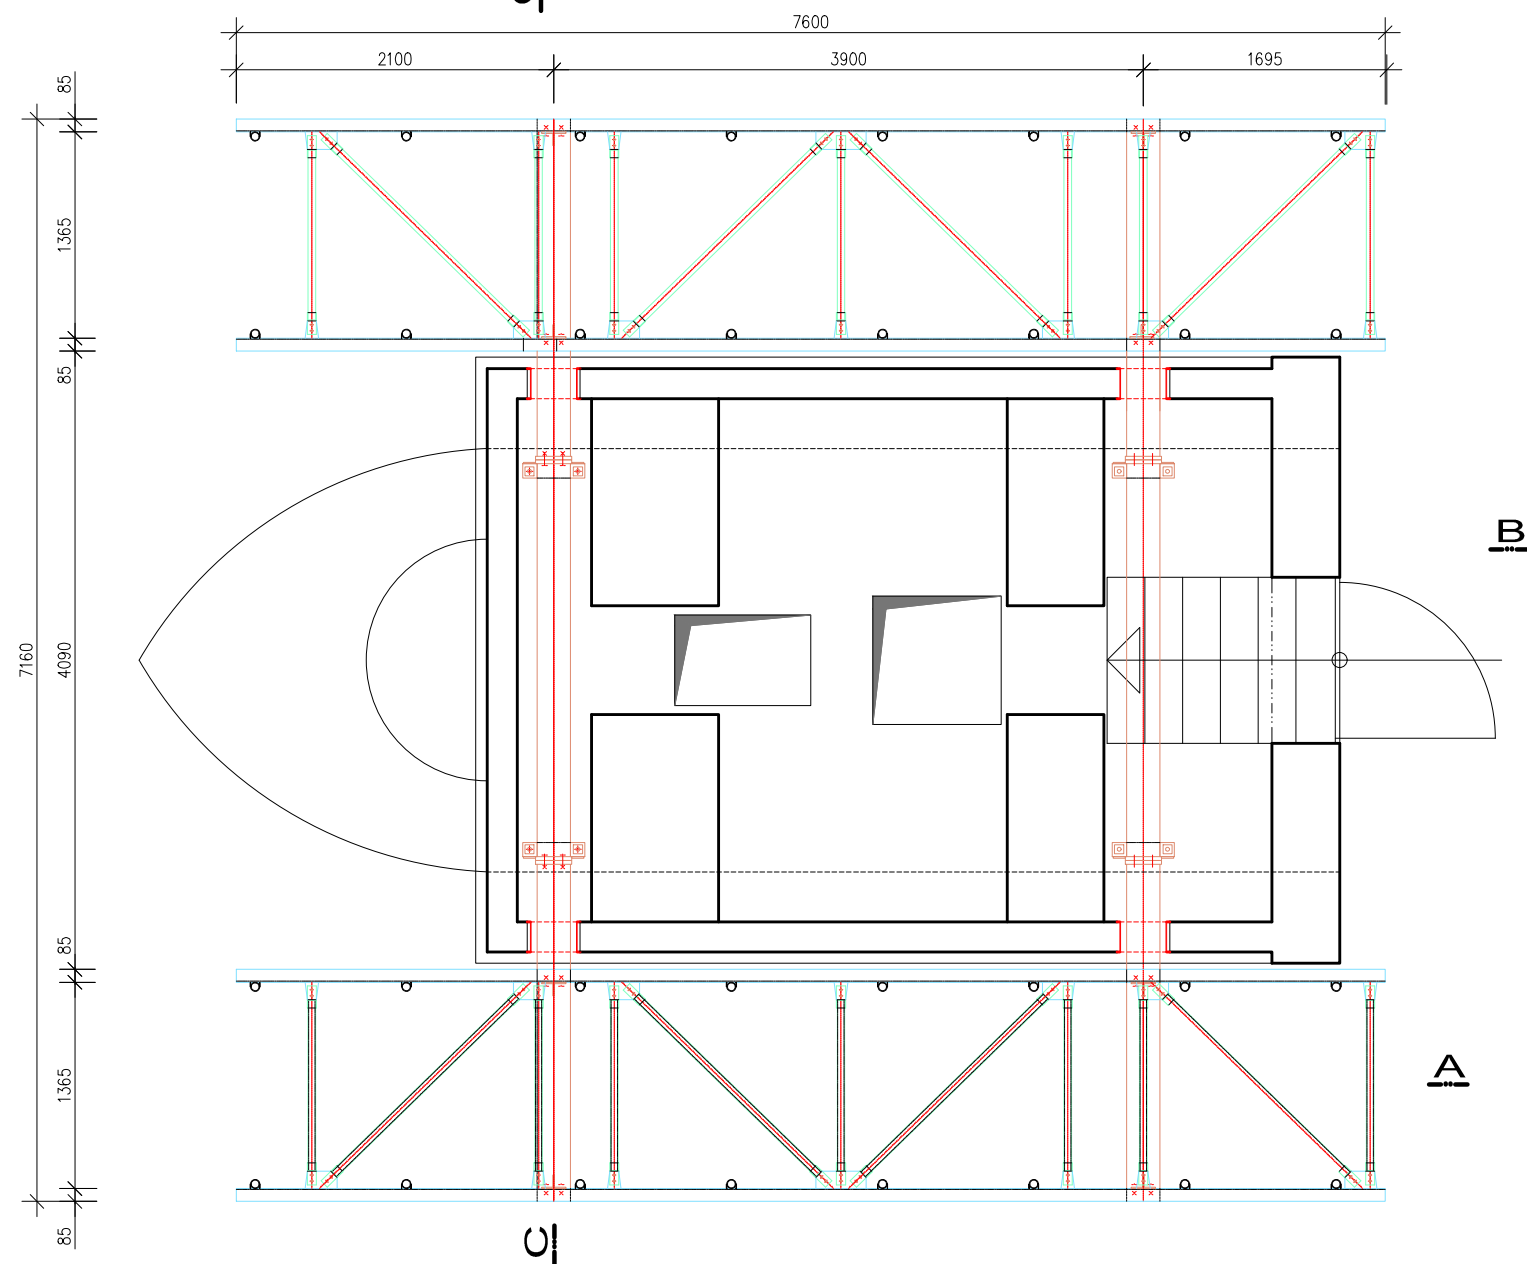
- U OBOU KRAJNÍCH STROJEVEN NEBUDOU KONZOLY VNĚ KORYTA MONTOVÁNY
